# 風力發電機葉片 防雷擊系統研討

Study on Lightning Protection System  
for Wind Turbine Blades

本文主要介紹風力發電機葉片受雷擊之狀況，並設計防雷擊裝置以保護風力發電機葉片避免因雷擊導致損壞。

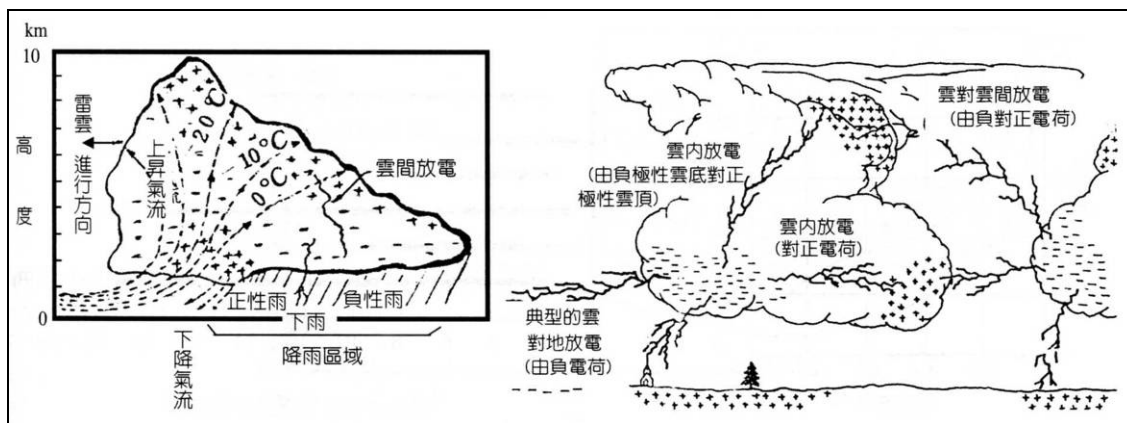
圖 1 雷雲產生及各種雷擊現象

一般來說，雷電的發生乃由於大地溫度升高，造成上升氣流並造成積雨雲，雲之正、負電荷被分離並積存在雲中形成雷雨胞，隨著時間累積相當數量電荷後，在雲層內、雲層與雲層間、或雲層與大地間就會存在著一個很強的靜電場 (static electric field)，當彼此電位超過其間空氣介質強度時則產生絕緣破壞而放電，雲層電荷就對地、雲或空氣釋放，產生所謂雷擊現象 (如圖 1)。
